RELATION H/T IN STRUCTURES OF BAHÍA DE CARAQUEZ AND THE 2016 EARTHQUAKE

R. Aguiar ^(1,2), V. Zambrano ⁽²⁾

Keywords: Relation H/T , Bahía de Caráquez, Earthquake 2016.

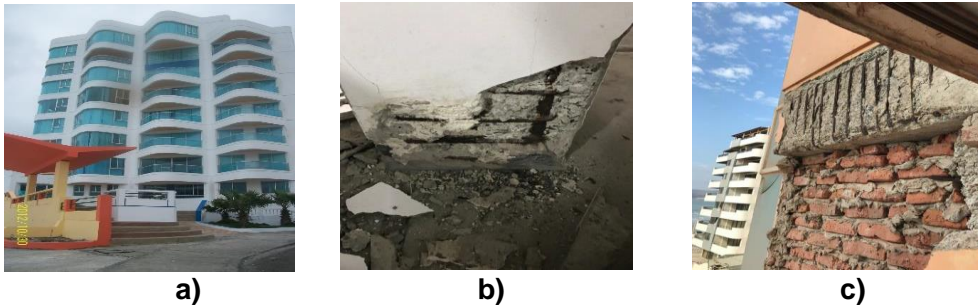
Figure 3. (a) The Vigia Building of 10 floors of HA; (b) Lost of covering in parking's column, strong corrosion in the rods of reinforcement; (c) High corrosion index in girders of elevator, stirrup without confinement.

The Watchtower building has a relation of average H/T of 26 is observed that there was moderated damage in structural elements in spite of the fact that a high corrosion index exists in the armor.

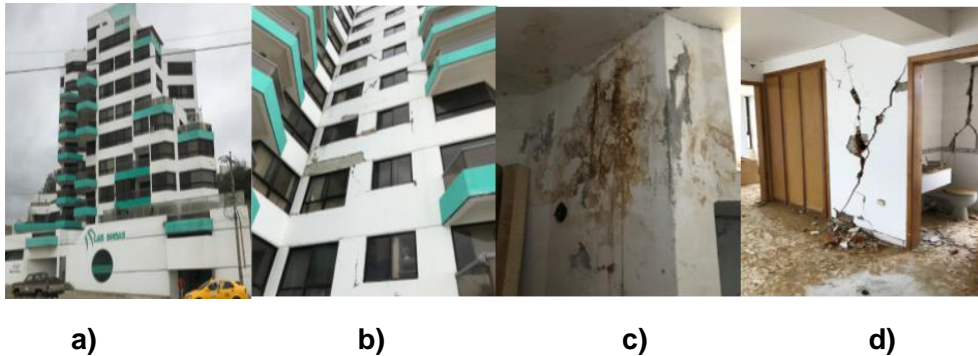
Figure 4. (a) The Brisas Building of 10 floors of reinforced concrete; (b) Lost of covering in some structural elements; (c) High corrosion index in girders; (d) Damages in masonry.

The Brisas building has a relation of average H/T of 30.80 is observed that there was corrosion in the steel of reinforcement so much of girders and columns in subsoil. Great damage in not structural elements.

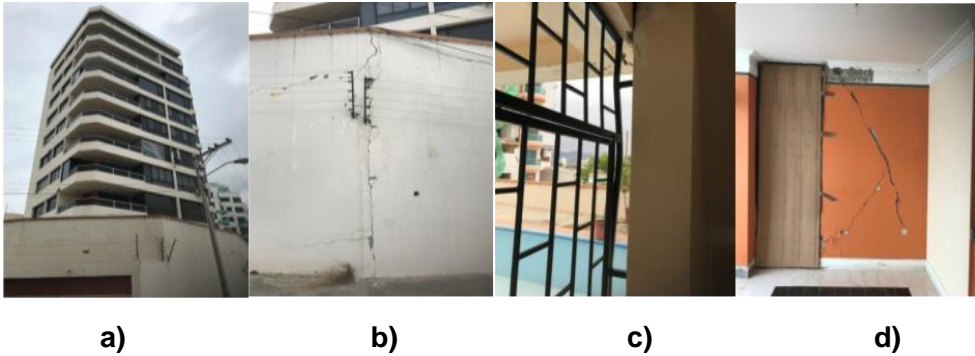
Figure 5. (a) The Horizonte Building of 10 floors of reinforced concrete; (b) The wall of containment presents a vertical fissure; (c) The perimetrales flounces suffered accession and product of this observes bulge in the door of access to the area of swimming pool; (d) Minor damages in internal masonry and broken windows.

The Horizonte building has a relation of average H/T of 22.25 are observed such damages as slight accession in perimetrales flounces, slight damages in masonry.

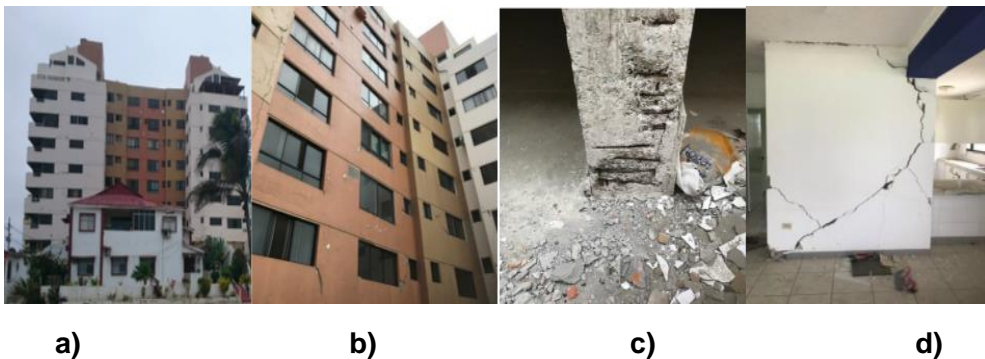
Figure 6. (a) Two Hemisferios building of 9 floors of reinforced concrete; (b) Detachment of covering in front; (c) Extensive damage in columns of social area; (d) Severe damages in interior and slight masonry in exterior masonry.

The Two Hemisferios building has a relation of average H/T of 12.60 structural damages are observed in the columns and in girders of some floors; to more of that it had damage in not structural elements.

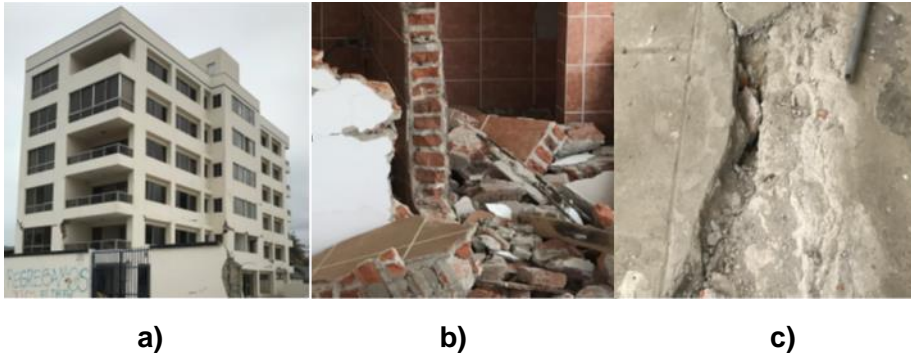
Figure 7. (a) The Delfín Building of 6 floors of reinforced concrete; **(b)** Detachment of covering in facade; **(c)** Severe damage in internal masonry.

The building Delfín has a relation of average H/T of 21.0 the damages that observed are severe in internal masonry, detachment of covering in facade, besides fissures in slab for cutting fault. Building was demolished post earthquake.

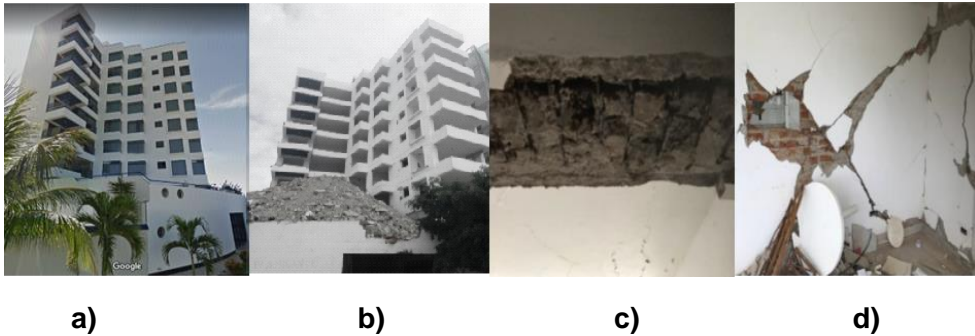
Figure 8. (a) The Almirante Building of 9 floors of reinforced concrete located in Bahía de Caráquez city; **(b)** Detachment of covering and fissures in front; **(c)**. Steel of reinforcement corroded in girder of social area; **(d)**. Detachment of internal masonry.

The Almirante building has a relation of average H/T of 20.90 the damages that are observed are severe in internal masonry, detachment of covering in facade, and damage in some of the columns of the social area and of the parking, in addition the reinforcement presents corrosion.

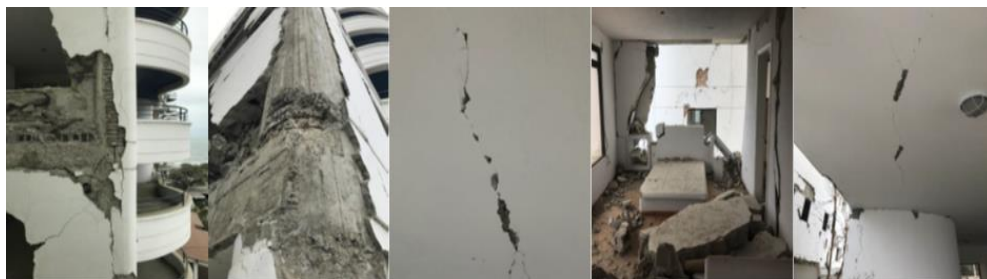
Figure 9. (a) The Mykonos Building of 10 floors of reinforced concrete; (b) Detachment of the covering of the column to the high of the whole floor.; (c) Failure of a vain of slab, close to nerve of the same (rotated photography); (d) Furniture store of concrete (e) Longitudinal fissure close to girder band.

The Mykonos building has a relation of average H/T of 19.45; the building presents strong damages in masonry and in some structural elements.

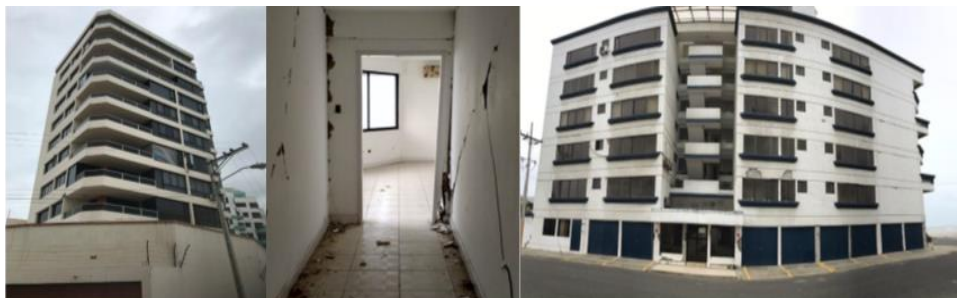
Figure 10. (a) The Pirata building of 7 floors of reinforced concrete; (b) Cracking in masonry; (c) Detachment of covering in frontal and posterior facade.

The building Pirata has a relation of average H/T of 22.90; though it had cracking in masonry these did not collapse.

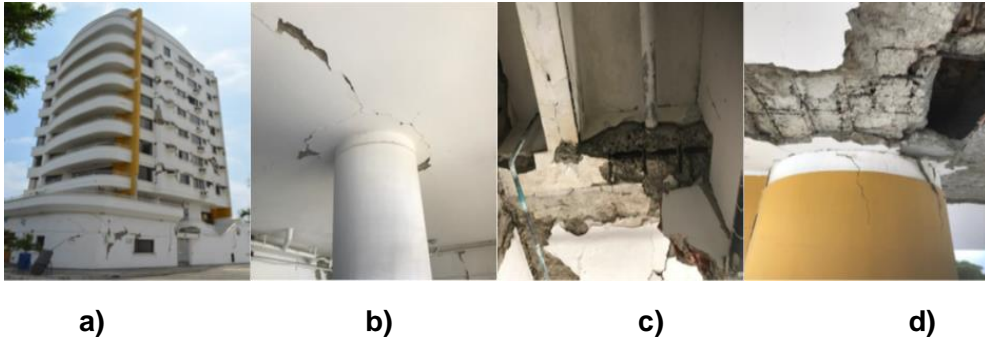
Figure 11. (a) The Salango building of 10 floors of reinforced concrete; **(b)** Failure for punching and longitudinal fissure in tile low close to the nerve; **(c)** Corrosion in structural elements of slab of cistern and slab of parkings; **(d)** Low tile in ground floor with corroded steel and without adherence.

The Salango building has a relation of average H/T of 23.25; it presents damages in masonry in some cases collapsed; is observed in addition steel of reinforcement corroded in girder that supports cistern.

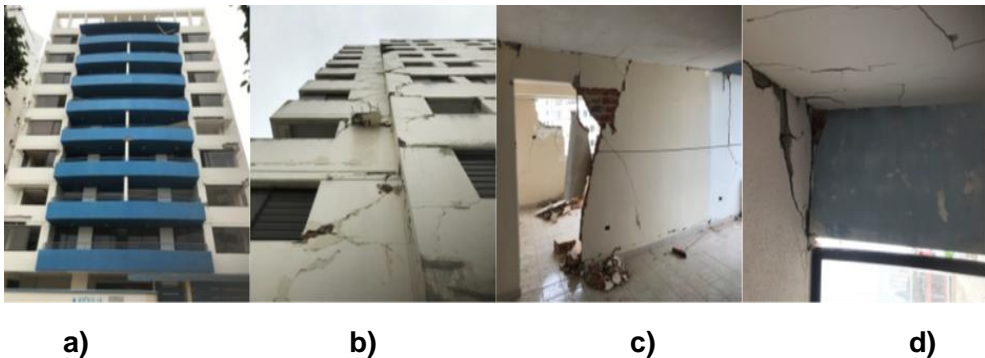
Figure 12. (a) The Spondylus Building of 9 floors of reinforced concrete; **(b)** Building's facade, major damage of masonry is not observed.; **(c)** Collapsed masonry supported by an electrical duct; **(d)** Cracking in relieved slab on facade window.

The Spondylus building has a relation of average H/T of 18.60; the damages are observed in masonry and detachment of covering in front, fissure in slab and masonry without vertical reinforcement not horizontally.

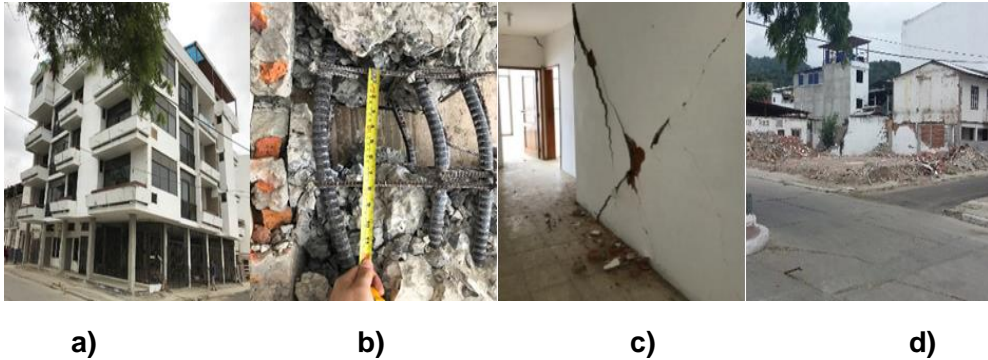
Figure 13. (a) The Cevallos building of 5 floors of reinforced concrete. (b) The formation of kneecaps repeats itself in 7 columns of ground floor in the facade posterior of the building; (c) Cracking of masonry they change according to the level of floor; (d) Demolished structure.

The Cevallos building has a relation of average H/T of 9.35; were observed damages and presence of plastic kneecaps in 8 columns. Poor detail in stirrups of confinement.

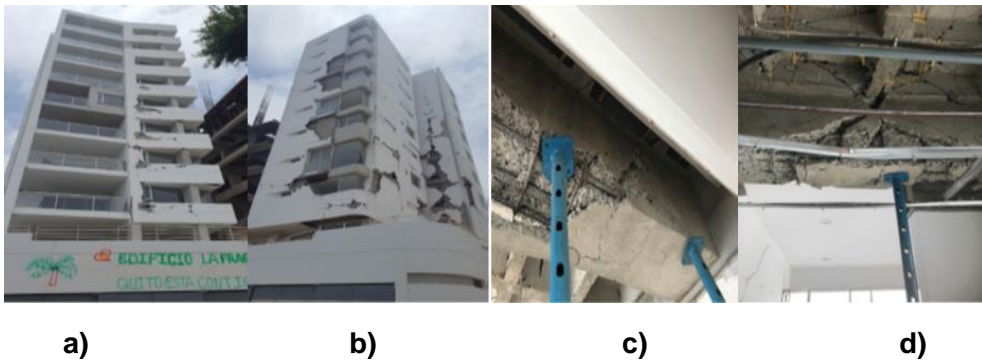
Figure 14. (a) The Fragatas Building of 10 floors of reinforced. (b) Detachment of covering in frontal and lateral facade; (c) Failure for butcher close to the right support of the girder; (d) Damage in girders and slab for butcher's effect.

The Fragatas building has a relation of average H/T of 28.60; damage in masonry. The photographs of the figures 14 (c) and (d) correspond to a short girder that penetrated into the not linear range into several floors. This building had damage in the columns of the social area, where the swimming pool was situated. It had a behavior of agreement to the philosophy of design and it was possible to reinforce (Aguar, 2017) but it was demolished.

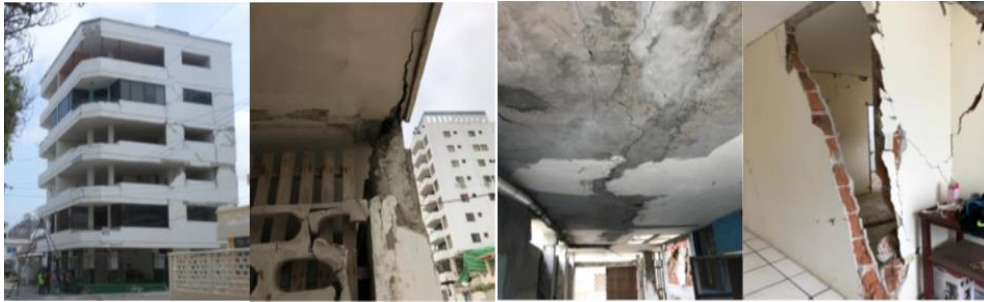
Figure 15. The Building Zedeño; **(a)** After The earthquake; **(b)** Damage in columns; **(c)** Crackings in panel of slab; **(d)** Collapse in masonry.

The building Zedeño has a relation of average H/T of 9.40; it presents damage in the top part of some columns of the ground floor, in slab, partial collapse of masonry. It is important bear in mind that the floors 3, 4 and 6 were not finished of repairing, after the affectation that had the building in the earthquake of 1998. In that way they had less weight during the earthquake of 16 A, which helped it in its behavior.

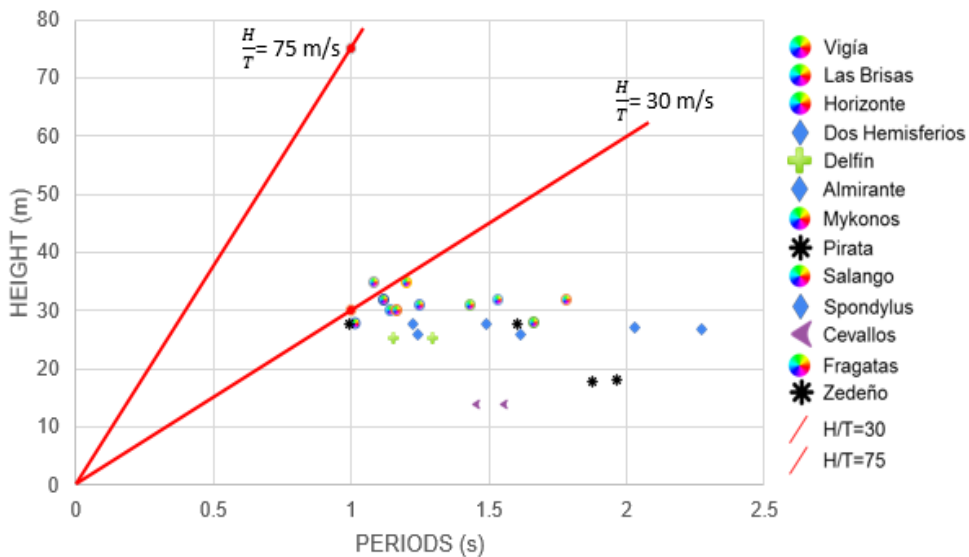
Figure 16 shows the values of the height of the buildings H and the experimentally found period, after the earthquake of April 16, 2016, it is seen that most of the points are at the bottom of the curve $\frac{H}{T} \leq 30$, which corresponds to flexible structures.

Figure 16 Relationship H/T found in buildings of Bahía de Caráquez, earthquake post 16 A. Source: This study.
