RELATION H/T IN STRUCTURES OF BAHÍA DE CARAQUEZ AND THE 2016 EARTHQUAKE

R. Aguiar ^(1,2), V. Zambrano ⁽²⁾

Keywords: Relation H/T , Bahía de Caráquez, Earthquake 2016.

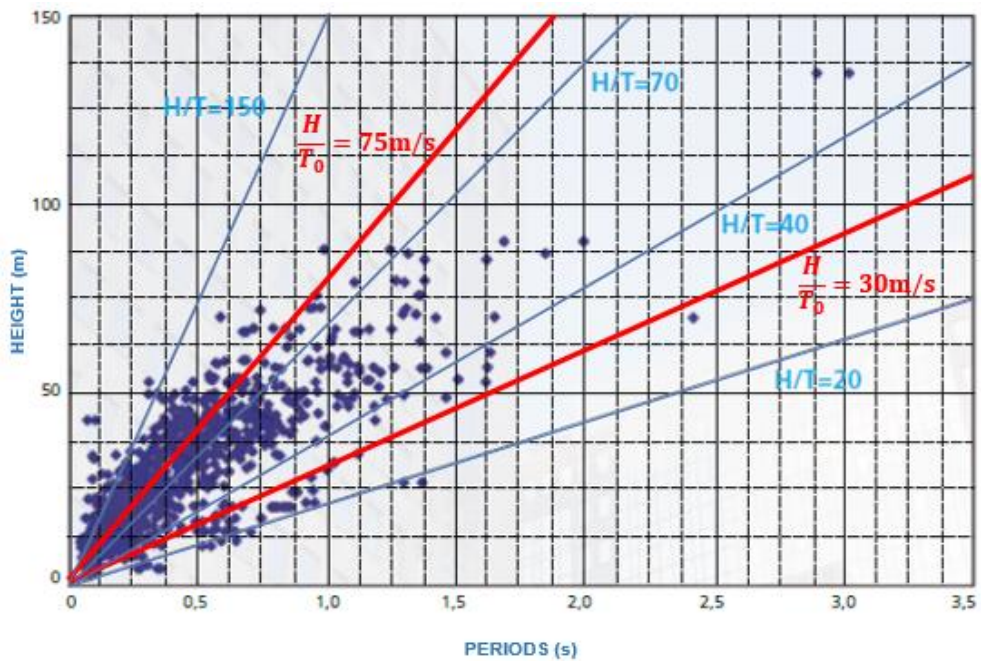
Figure 1 Values of height of floors and periods met analytical thick inertias, of structures from Chile. **Source:** Guendelman *et to.* (2012)

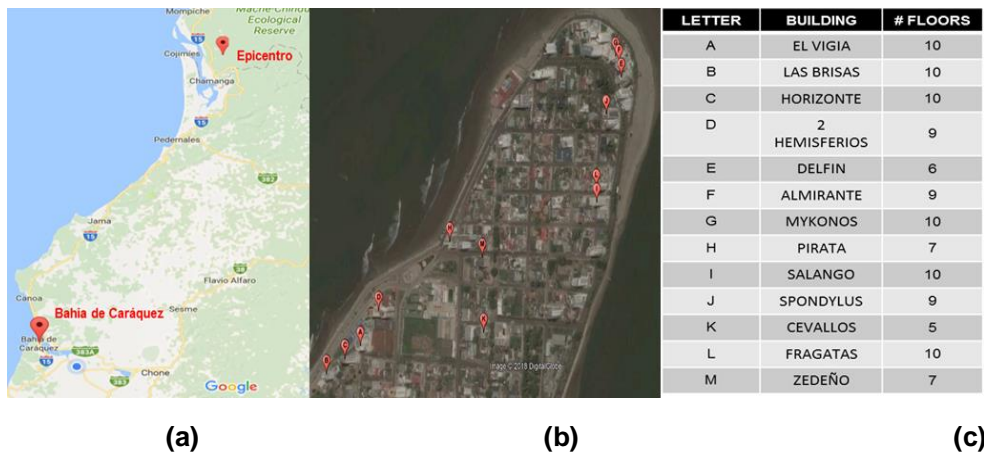
Figure 2 (a) Location of the Epicentre of the earthquake of April 16, 2016 and of the Bahía de Caráquez city; (b) Location of the buildings in those who were obtained the period of vibration; (c) Identification of the buildings and number of floors.
